# **ESTCP Cost and Performance Report**

## Thermal Spray Removal of Lead-Containing Paint of Steel Structures

June 1999

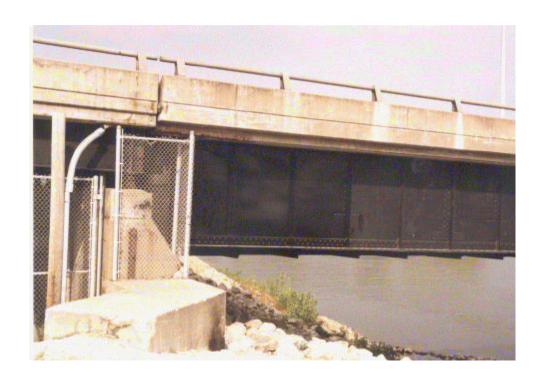
Figure 2. Rock Island Bridge Showing Area of TSV Demonstration

The first site was the viaduct bridge located at the Rock Island Arsenal, Illinois. The viaduct bridge connects the Rock Island Arsenal and the City of Rock Island and has two lanes for vehicle traffic. The bridge design is typical of Federal highway and Army bridges. It was coated with a lead-containing primer and alkyd topcoats. The demonstration of the TSV process was conducted in 1997 on a section of a horizontal steel beam below the traffic deck of the bridge, on the first three panels of the eastern- most bridge girder on the north (river) side of Pier No 8. Scaffolding was constructed to provide access to the girder. A ramp provided access to the scaffolding from the levy that abuts Pier No. 8. Figure 2 is a photograph of the site.

During the initial application of the TSV process, it was noted by the operator that the vertical web of the beam was warping from the heat of the process. The application of the TSV process was immediately stopped and the degree of warping was measured and found to range up to 3/8 inch. A structural engineer from the Corps of Engineers, Rock Island District inspected the beam and concluded that the warping did not adversely impact the structural integrity of the beam or the bridge. The maximum temperature recorded was 273 °C (523 °F) and 322 °C (611 °F). The TSV procedure was modified to eliminate the use of a separate torch to preheat the substrate. The thermal spray torch was used in a more controlled manner to preheat the substrate and the amount of warping was minimized.

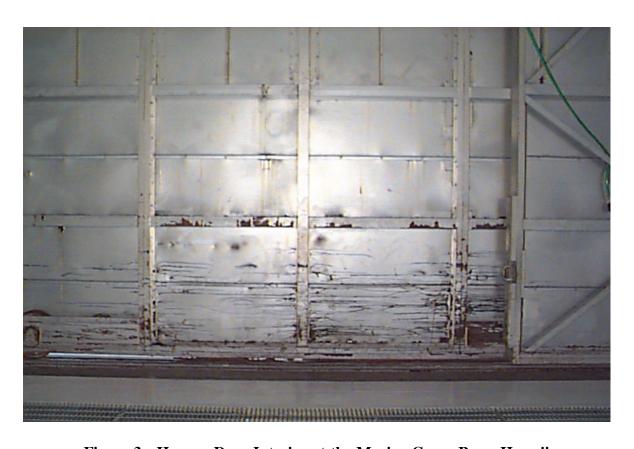
Figure 3. Hangar Door Interior at the Marine Corps Base, Hawaii

The second site was a hangar door, representative of hangars in the DoD, located on a portion of Hangar 3, Building 103 at the Marine Corps Base, Kaneohe Bay, Hawaii (MCBH). The TSV process was applied to the flat outside door surface and to flat surface and beams on the interior of the door. The hangar was undergoing rehabilitation, which provided a challenge for lead-containing paint abatement because the floor was newly refinished adjacent to the interior of the hangar door. Figure 3 is a photograph of the door interior.
